M&D milestone no. 3 (4)

MHT-HSI no. CE-IV-1013

FIELD SHEET: MASON & DIXON LINE, MARYLAND-PENNSYLVANIA BOUNDARY MARKER SURVEY

MASON & DIXON WEST LINE: MILESTONE NO. 3(4)

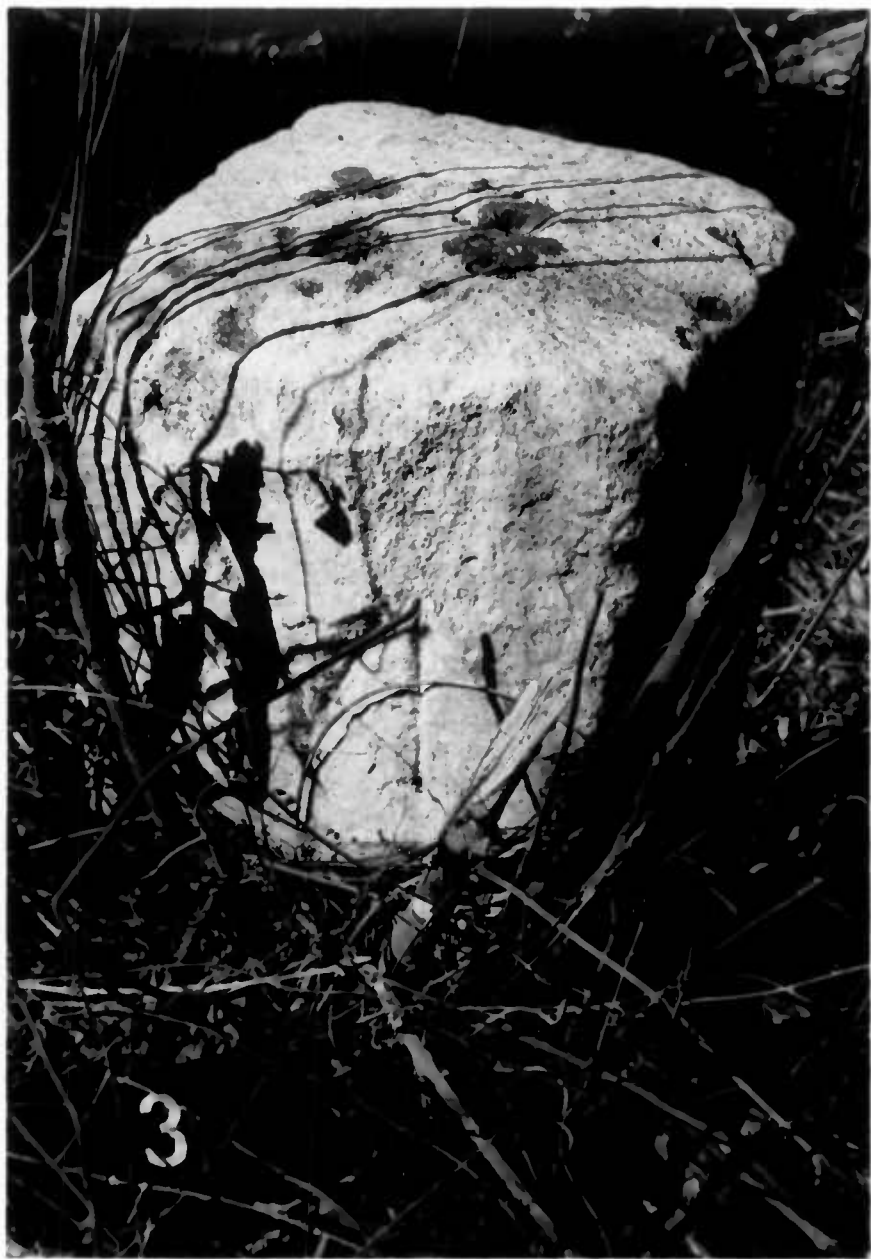
WAGON & DITCH WEST SIDE N. E. QUARTER 10.0.0
SE CORNER (M-1)

top: no planes visible; badly weatherworn; all edges & corners chipped, big chip SE corner

3 (4) Original M&D milestone of 1766 in fair condition, firmly set; letters damaged; big chips all corners & edges; all faces & top badly weatherworn, most margins gone, some fluting distinct; protected by site.

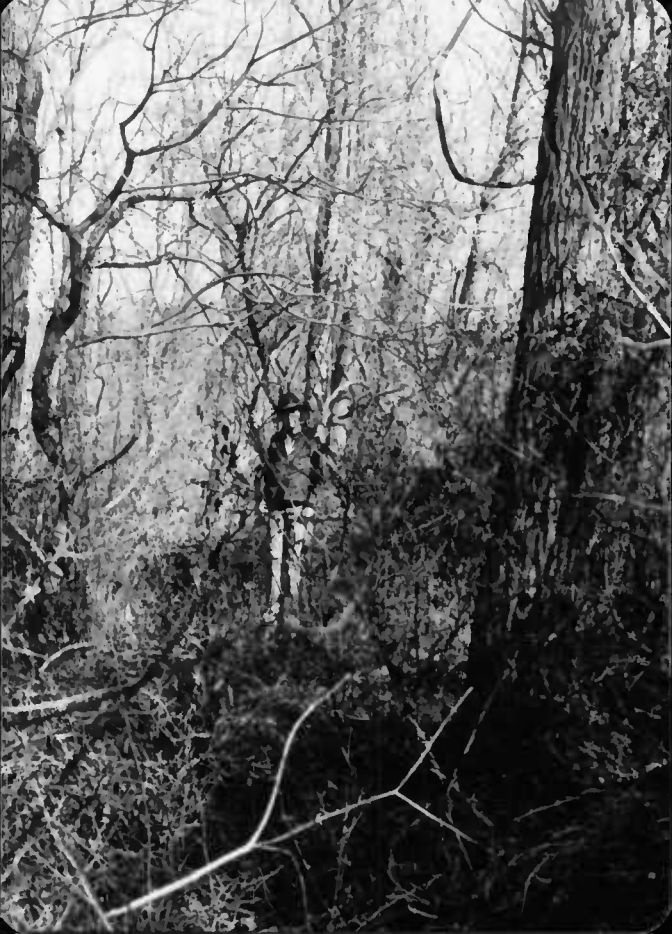
MILESTONE NO. 3

VIEW EAST TOWARD MIKE
PEROZZIELLO IN STONE

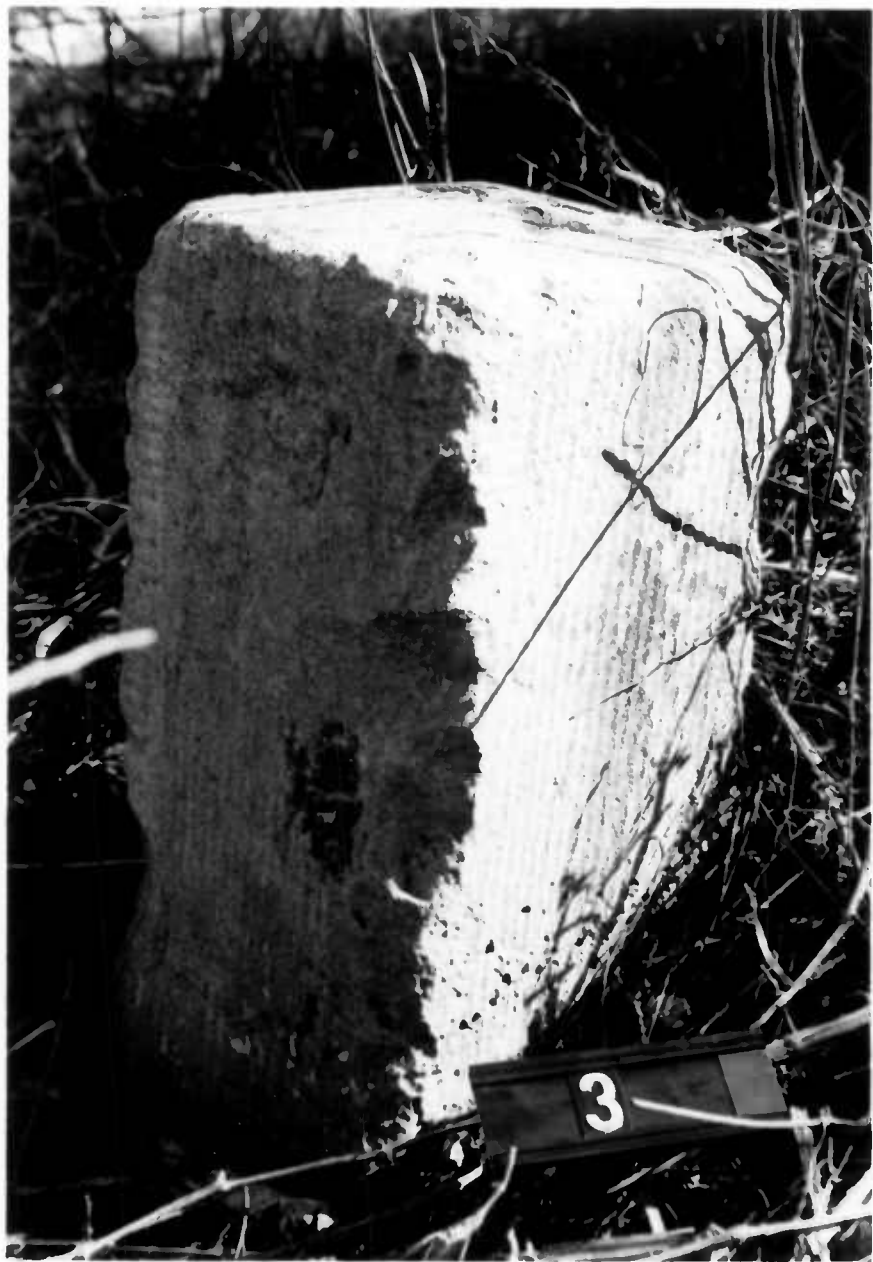
MASON & DIXON WEST LINE: MILESTONE NO. 3
NW CORNER (P1-)

N face (PA): 11 1/2" wide x 25" high; P is badly chipped & worn; as is face

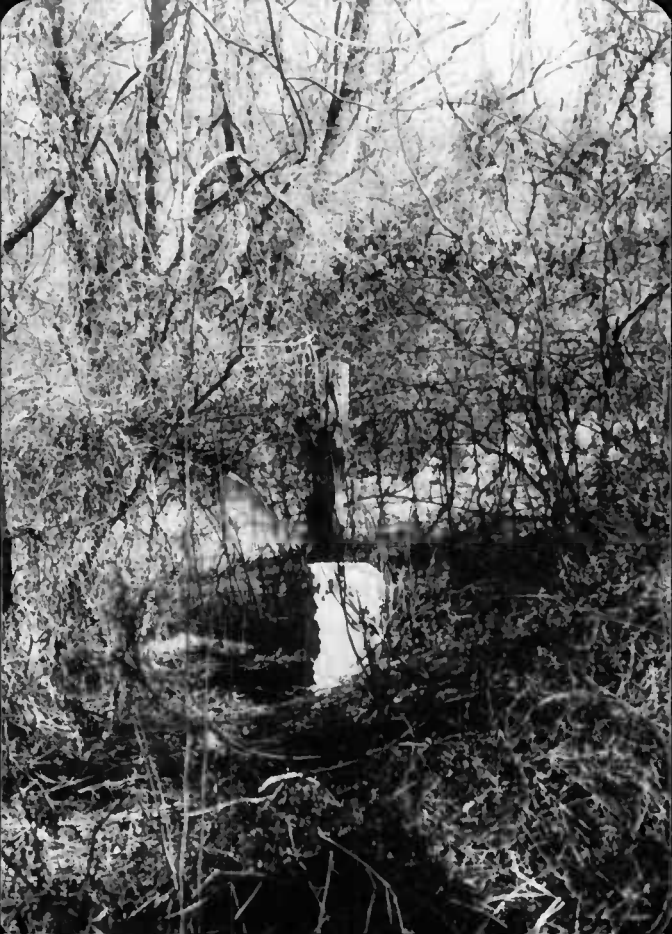
STONE NO. 3 NW CORNER

(P/-) LOOKING ESE

OLD LOGGING RD
